## **Silverthorn Collegiate Institute**

Accessibility survey date: June 2014

For public: summary  
and site plan

# Silverthorn Collegiate Institute Site Plan

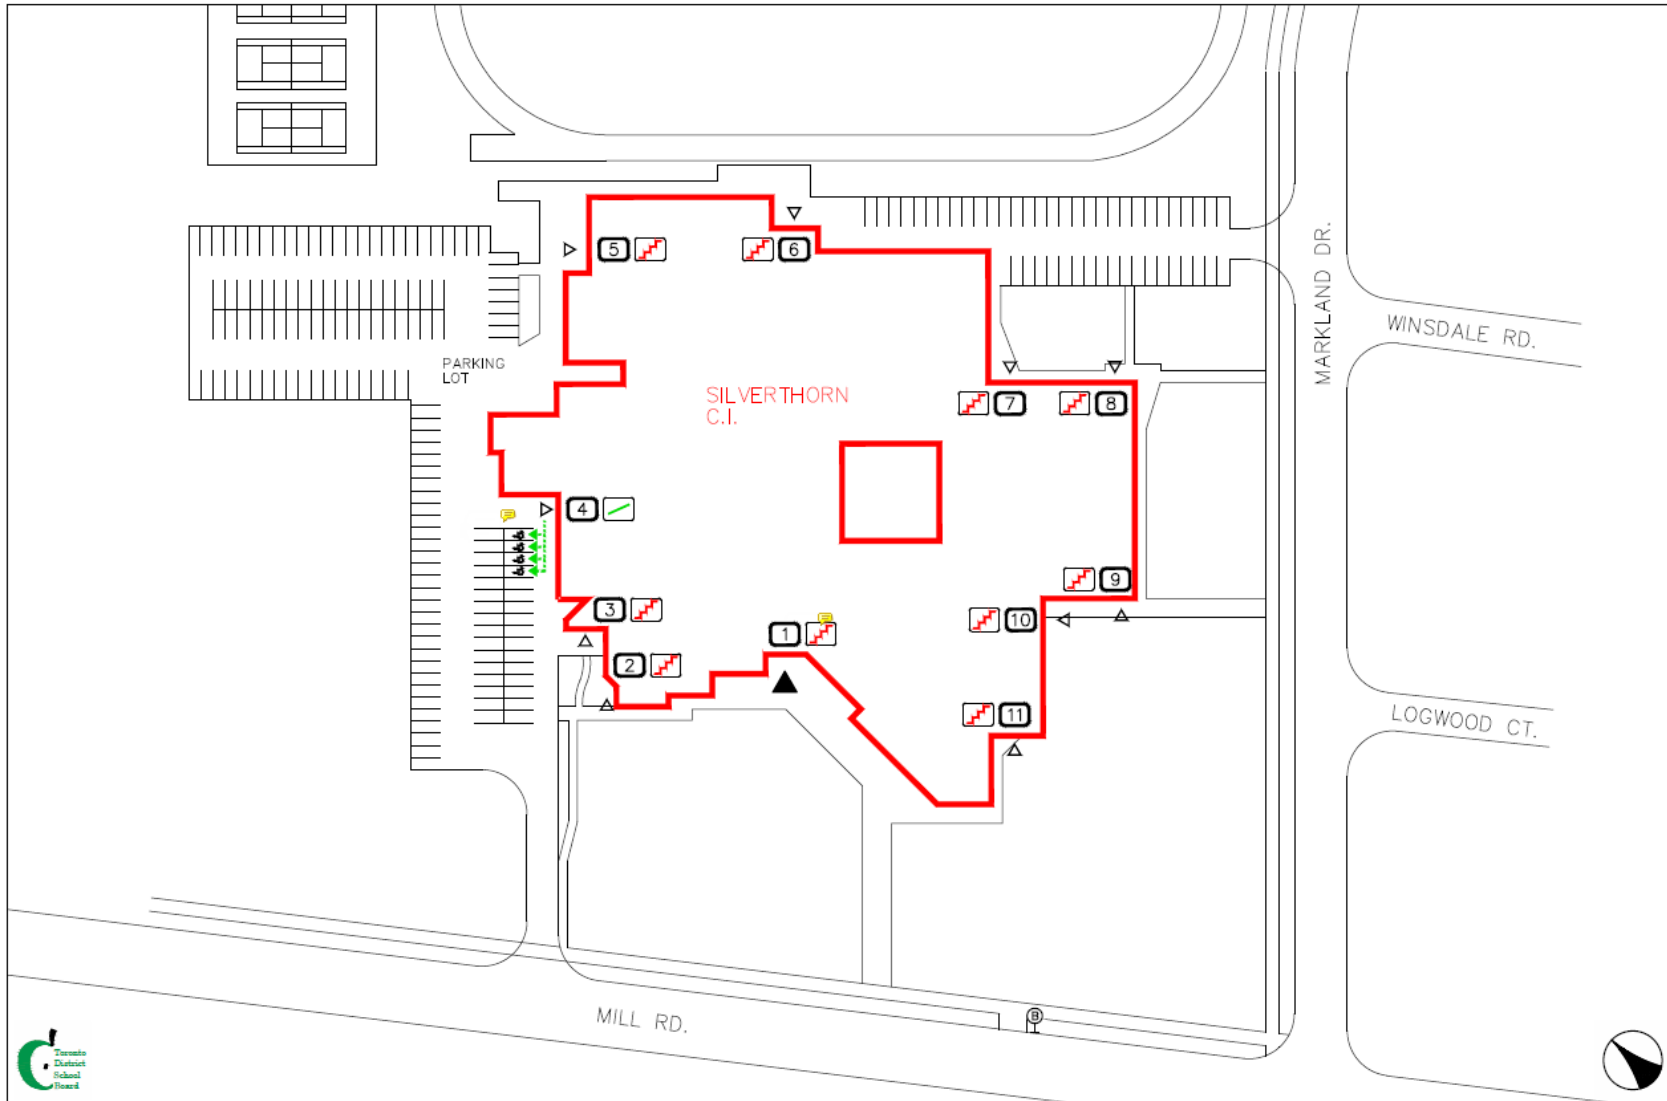
Facility #: 0438

The school is not accessible. It has one accessible washroom, but no accessible entrances. Also, there is no elevator to facilitate access between floors.

**Parking:** There are four accessible parking spaces with easy access to entrance #4.

**Pathways:** Entrance #4 is located close to the parking lot, but there is no definite path present. Entrance #2 is the best route to the sidewalks. The play field can be accessed from entrance #5.

**Entrances:** There are no entrances equipped with power-operated doors. The main entrance is not accessible because there is a set of stairs leading to it.
