Amesbury Middle School

Accessibility survey date: January 2015

For public: summary
and site plan

Accessibility: Features and Barriers

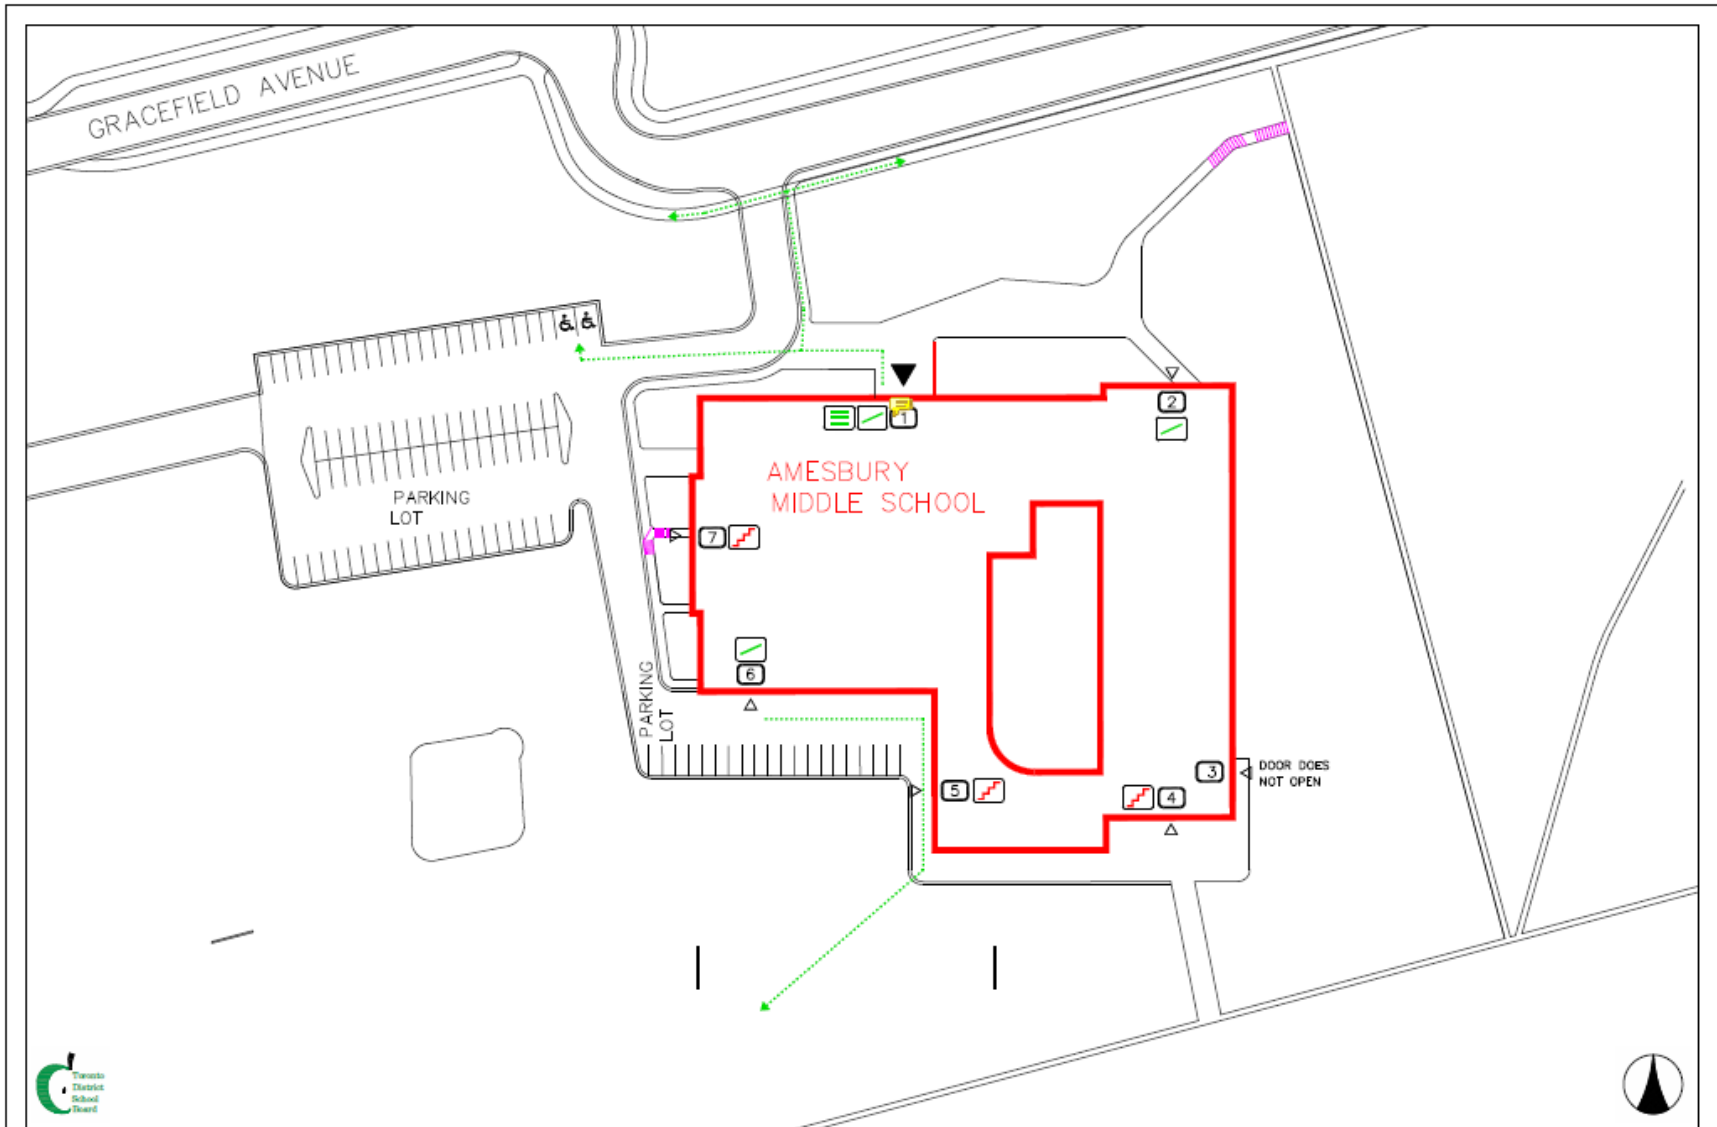
<p>Facility</p> <p>Amesbury Middle School</p>	<p>Facility #</p> <p>0030</p>
<p>Address</p> <p>201 Gracefield Avenue North York</p>	<p>Sheet Title</p> <p>Site Accessibility Plan</p>
<p>M6L 1L7</p>	<p>Last Update</p> <p>2014-09-17</p>

Parking: There are two accessible parking spaces located at the bottom of a very steep hill, near entrance #1, which is the recommended entrance. A person using a mobility device may need assistance.

Pathways: All exterior pathways are accessible, although entrances may have barriers. The school is built on a hill, so a person using a mobility device may have challenges. There is very little paved area for outdoor play for a person using a mobility device.

Entrances: No entrances are equipped with power-operated doors. Entrances #1 and #2 are level and entrance #6 is ramped. Entrance #1 is recommended for pick-up and drop-offs for a person with a mobility device. This is also the entrance located nearest to the accessible parking.
