## Accessibility: Features and Barriers

# Owen Public School

111 Owen Blvd, North York, ON M2P 1G6

Accessibility survey date: June 2015

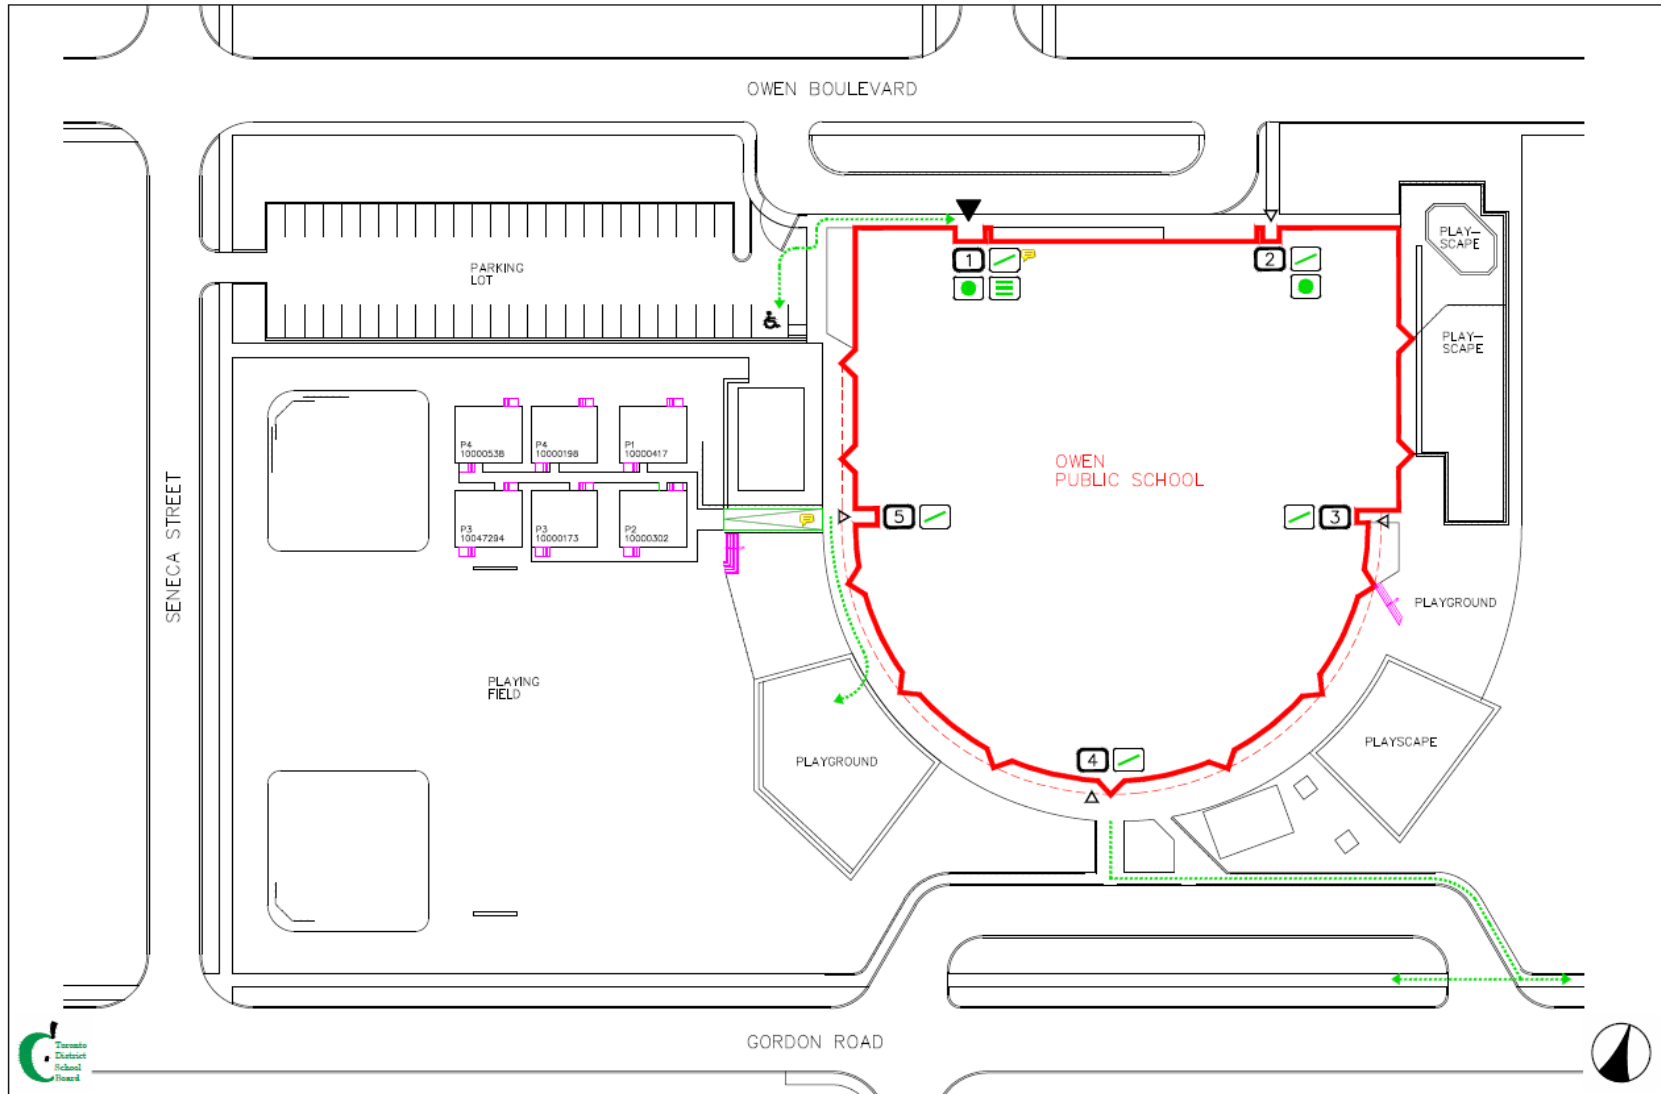
Owen Public School Site Plan

This school is somewhat accessible. There are two entrances (entrance #1 and entrance #2) equipped with power-operated doors. However, entrance #2 has been blocked off and is not being used. There are two floors in this school. The second floor is the upper part of the library/computer lab and a mechanical room. There are only stairs to access this. The interior routes of this school are not level, but they are addressed with ramps. There are also two accessible washrooms. There is a ramp to access the portables as well.

**Parking:** There is one accessible parking space near entrance #1, which is level and equipped with a power-operated door.

**Pathways:** Most exterior routes are not barrier free. Some entrances lack power-operated doors, and some routes have cracked and uneven pavement.

**Entrances:** Entrance #1 and entrance #2 are equipped with power-operated doors. However, entrance #2 has been blocked off. Entrances #1, #3, #4 and #5 are level.
