St Andrew's Junior High School

Accessibility survey date: May 2014

For public: summary
and site plan

Accessibility: Features and Barriers

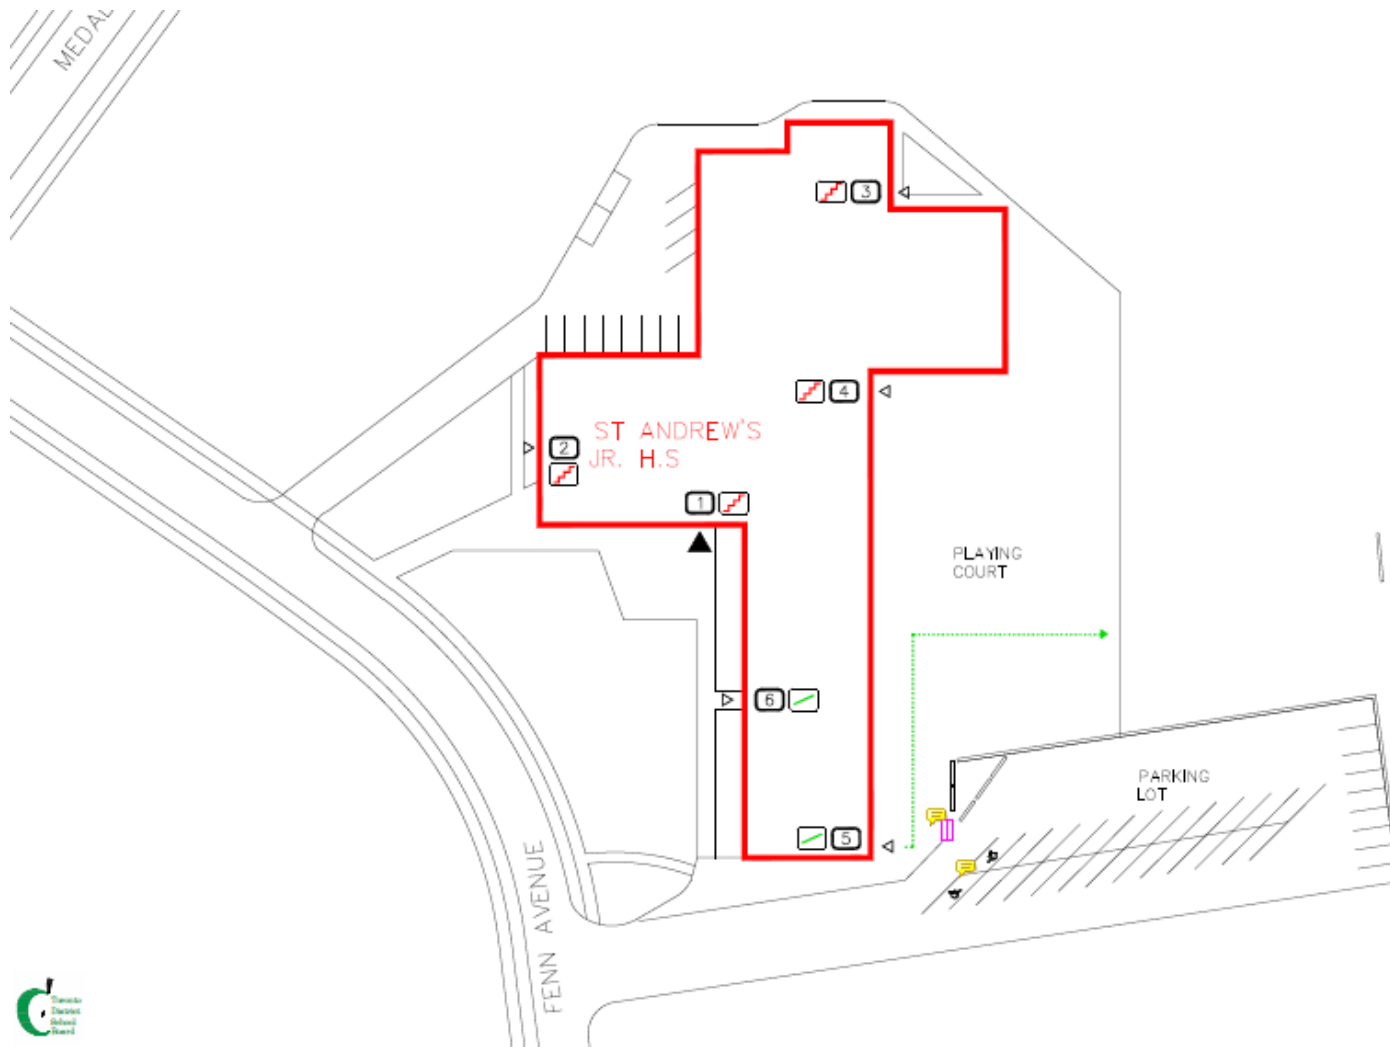
This school is not accessible. There are no accessible washrooms or entrances. In addition, the school needs an elevator to facilitate access to all floors.

Parking: There are two accessible parking spaces near an inaccessible entrance.

Pathways: The parking lot and the path from the accessible parking space to the entrance have excessive cracking in the pavement and there are pot holes. There are also steps on the path.

Entrances: The main entrance is inaccessible due to the presence of steps as well as the lack of a power-operated door. However, there is a ramp to compensate for a step at the main entrance.
