## **Birch Cliff Heights Public School**

Accessibility survey date: July 2014

For public: summary  
and site plan

## Accessibility: Features and Barriers

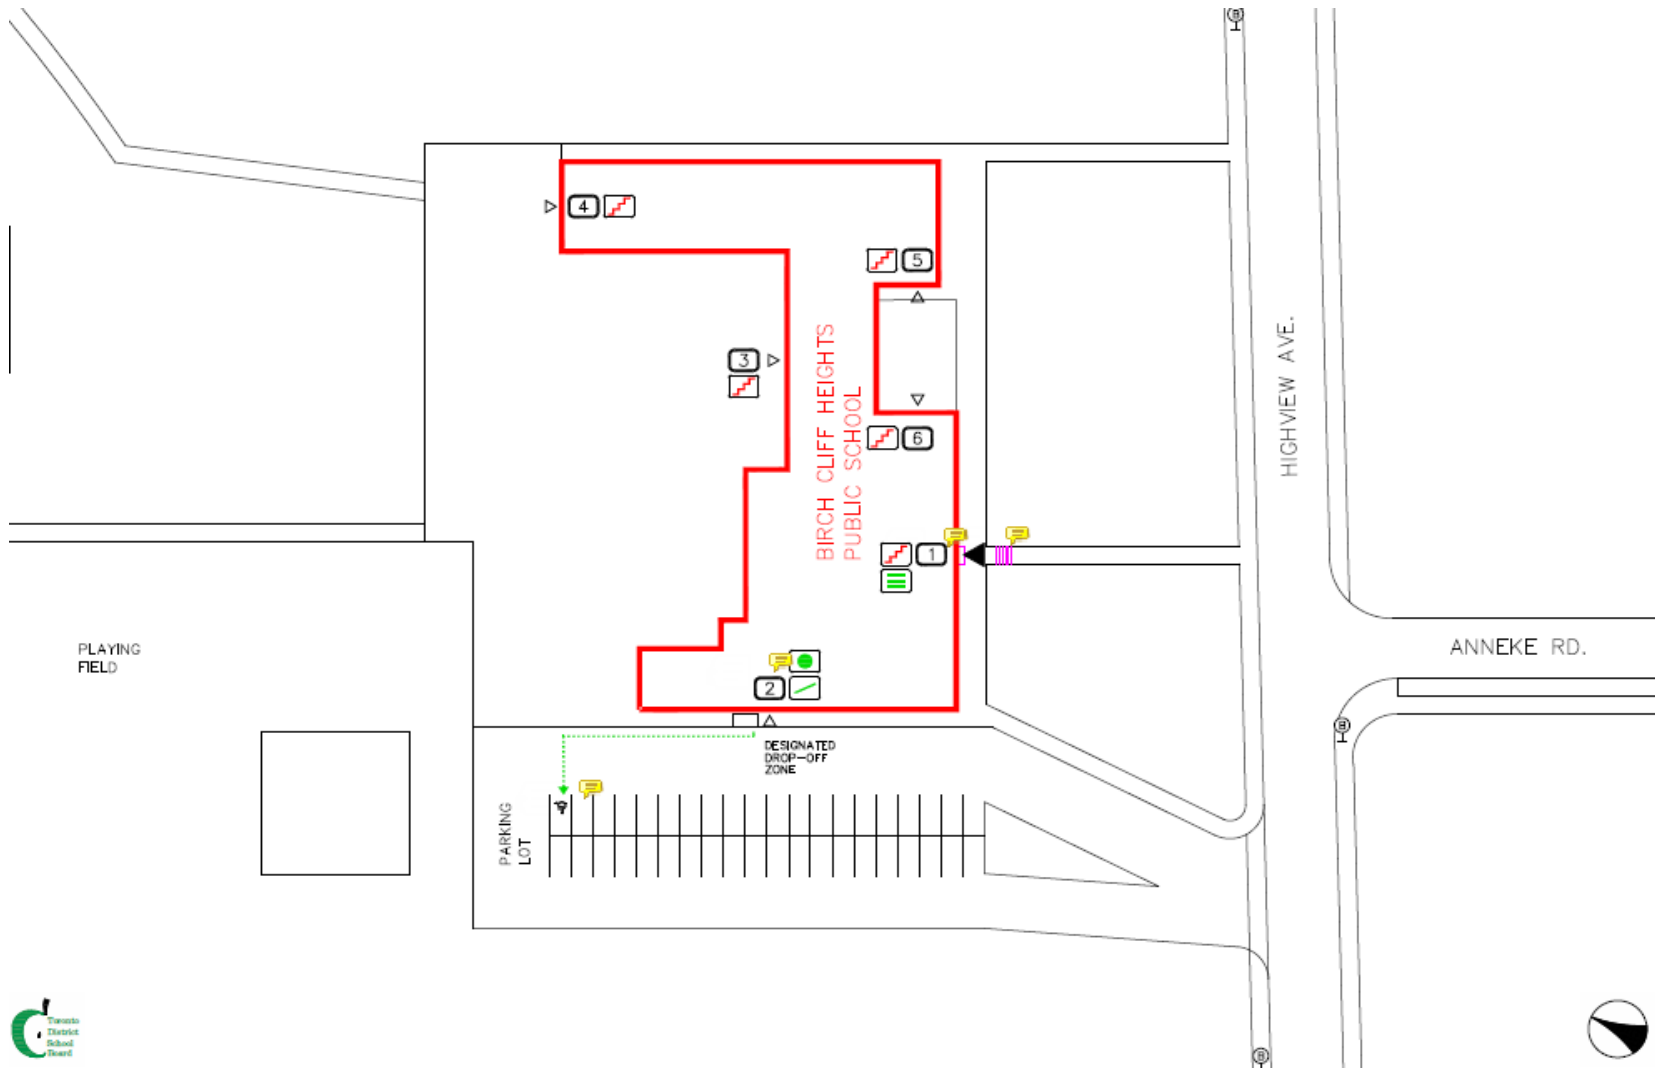
**Birch Cliff Heights Public School**

Birch Cliff Heights Public School is not accessible. The school does not have an elevator to facilitate access to all floors. In addition, there are no accessible washrooms or accessible entrances equipped with electronic door operators.

**Parking:** This school has one accessible parking stall located near entrance #2.

**Pathways:** Most exterior routes are inaccessible due to presence of stairs, steps, and steepness of pathways and alligator cracks.

**Entrances:** This school does not have an entrance equipped with an electronic door operator. However, entrance #2 is sloped.

**Floor Access:** This school does not have an elevator; therefore, the basement and the second floor are inaccessible. In addition, most height differentials on the first floor are not addressed by a ramp or a lift.
