# St Andrews Public School

60 Brimorton Dr, Scarborough, ON M1P 3Z1

Accessibility survey date: July 2014

For public: summary  
and site plan

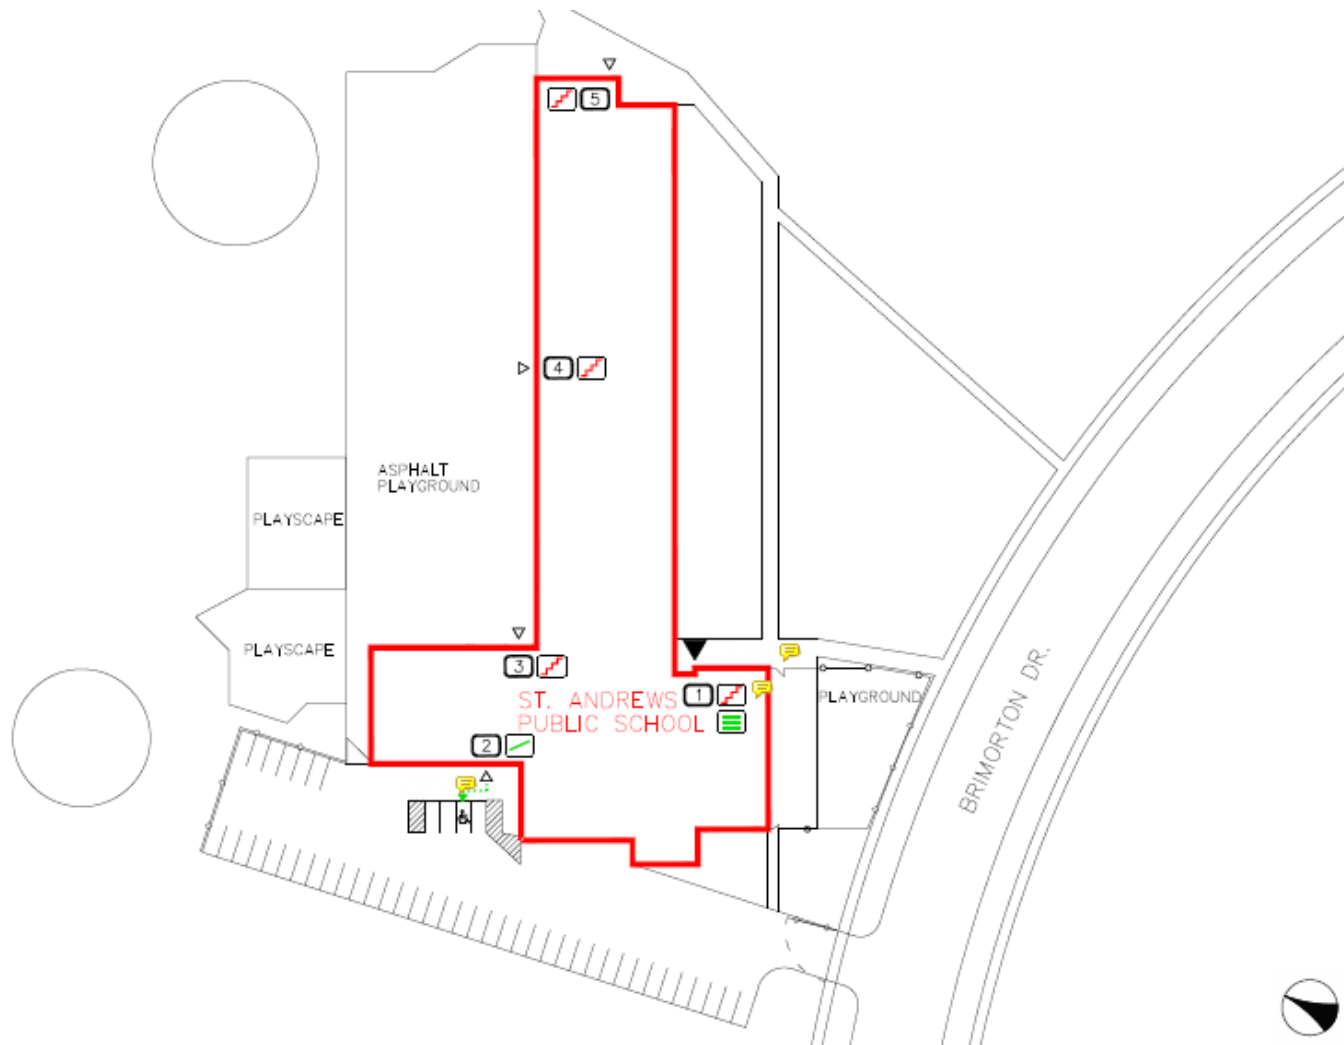
### Accessibility: Features and Barriers

The school is not accessible. There are no designated accessible entrances equipped with power-operated doors. The school also does not have any accessible washrooms. In addition, floor access is limited to the first floor.

**Parking:** There is one accessible parking space near entrance #2.

**Pathways:** Most exterior routes have from steps.

**Entrances:** There are no entrances equipped with power-operated doors. The main entrance is stepped and is not accessible. However, entrance #2 is sloped.

**Floor Access:** There is no elevator in the school, so the second floor is not accessible.

**Washrooms:** There are no accessible washrooms in the school.
