# Malvern Collegiate Institute

Accessibility Survey Date: July 2014

For public: summary  
and site plan

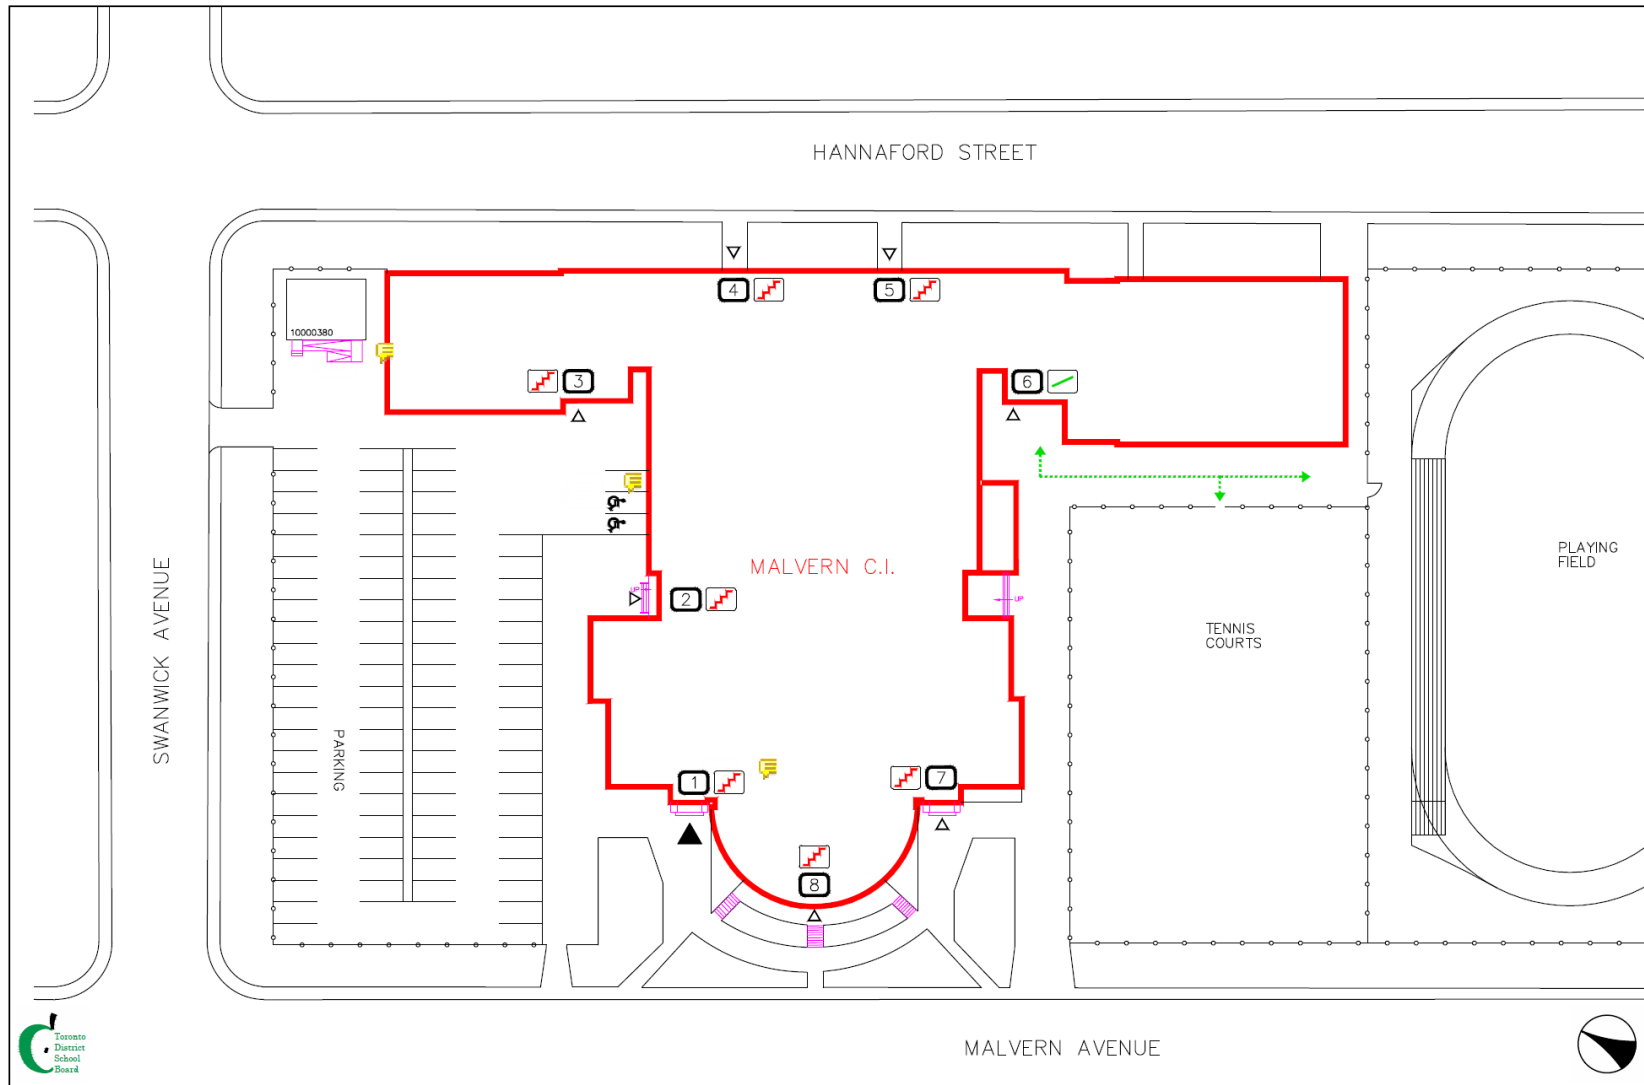
Malvern Collegiate Institute Site Plan

The school is not accessible. None of the entrances are accessible as most have a steps leading to them. There are no accessible washrooms. There are no elevators suitable for people to use in the school.

**Parking:** There are two accessible parking spots near entrance #3.

**Pathways:** All exterior routes are obstructed by steps. As well, the parking lot has cracks and potholes.

**Entrances:** None of the entrances are designated accessible or have a power-operated door. The main entrance is stepped. However, entrance #6 is sloped.
