Etienne Brule Jr School

Accessibility survey date: August 2014

For public: summary
and site plan

Accessibility: Features and Barriers

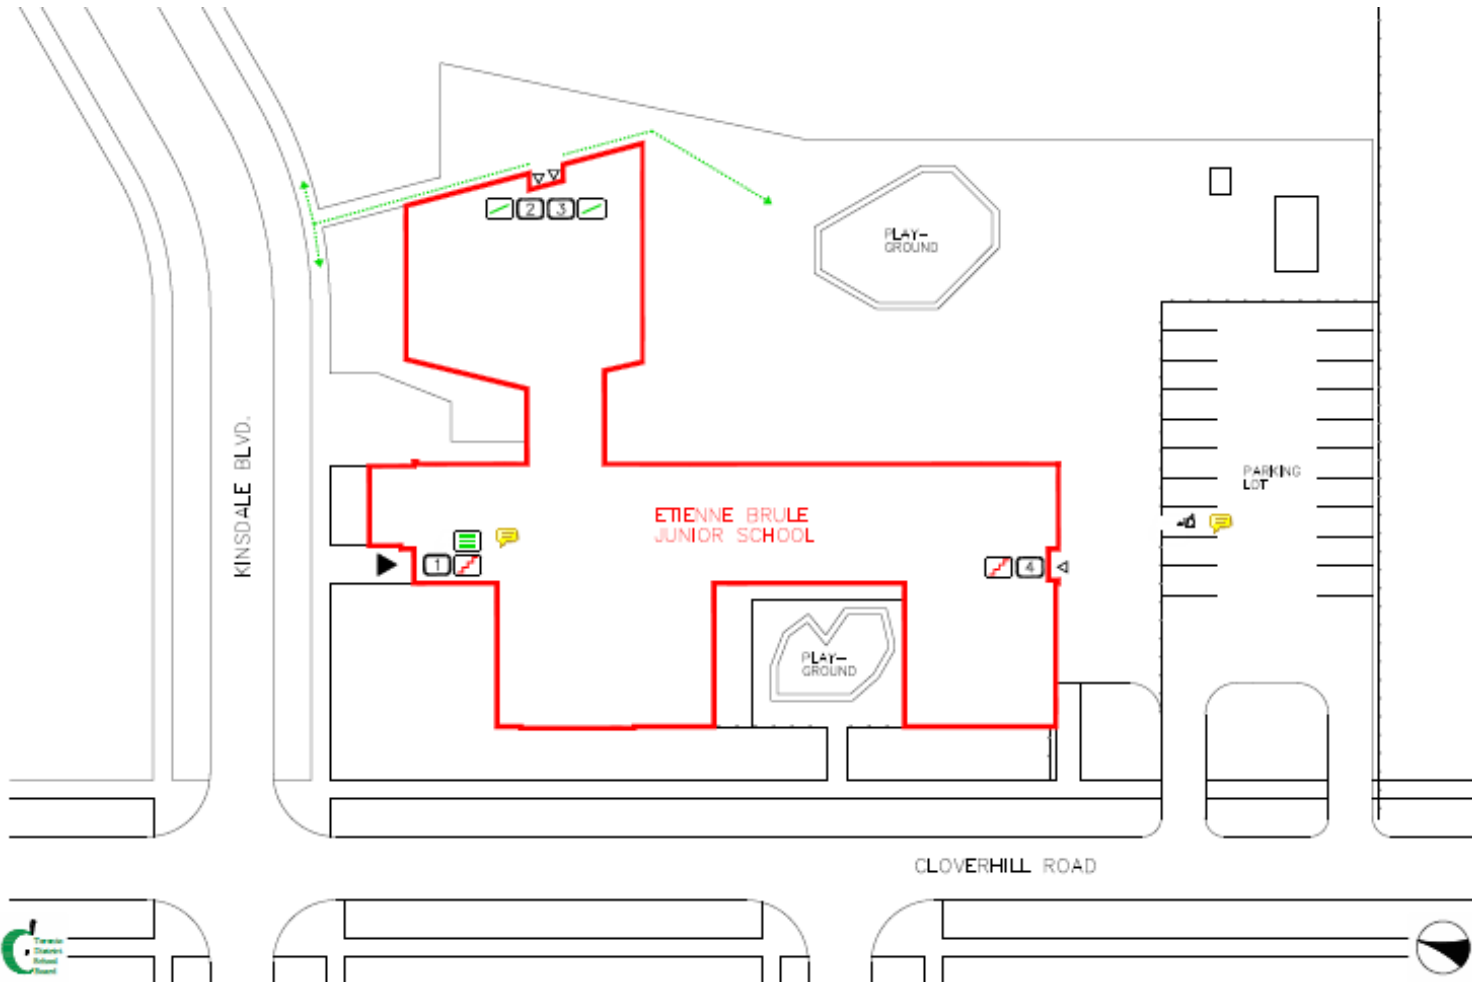
Etienne Brule Junior School

The school is not accessible. There is no elevator in the school, so the second floor is inaccessible. In addition, there is no entrance equipped with power-operated doors or accessible washroom. However, all specialized rooms, except the library, are on an accessible route.

Pathways: All exterior routes are accessible. However, the distance from the accessible parking spot to a level entrance is extremely far.

Entrances: Entrances #2 and #3 are level but do not have power-operated doors. Other entrances all have barriers such as steps or stairs.

Floor Access: There is no elevator in the building, so only the main floor is accessible.

Main Office: The main office is somewhat accessible; no power-operated door.

Library: The library is on the second floor which is not on an accessible route.

General Purpose/Gymnasium: The general purpose room is somewhat accessible; no power operated door. The stage is not accessible.

Washrooms: There are no accessible washrooms in the building.
