SATEC @ WA Porter Collegiate Institute

40 Fairfax Cres, Scarborough, ON M1L 1Z9

Accessibility survey date: June 2014

For public: summary
and site plan

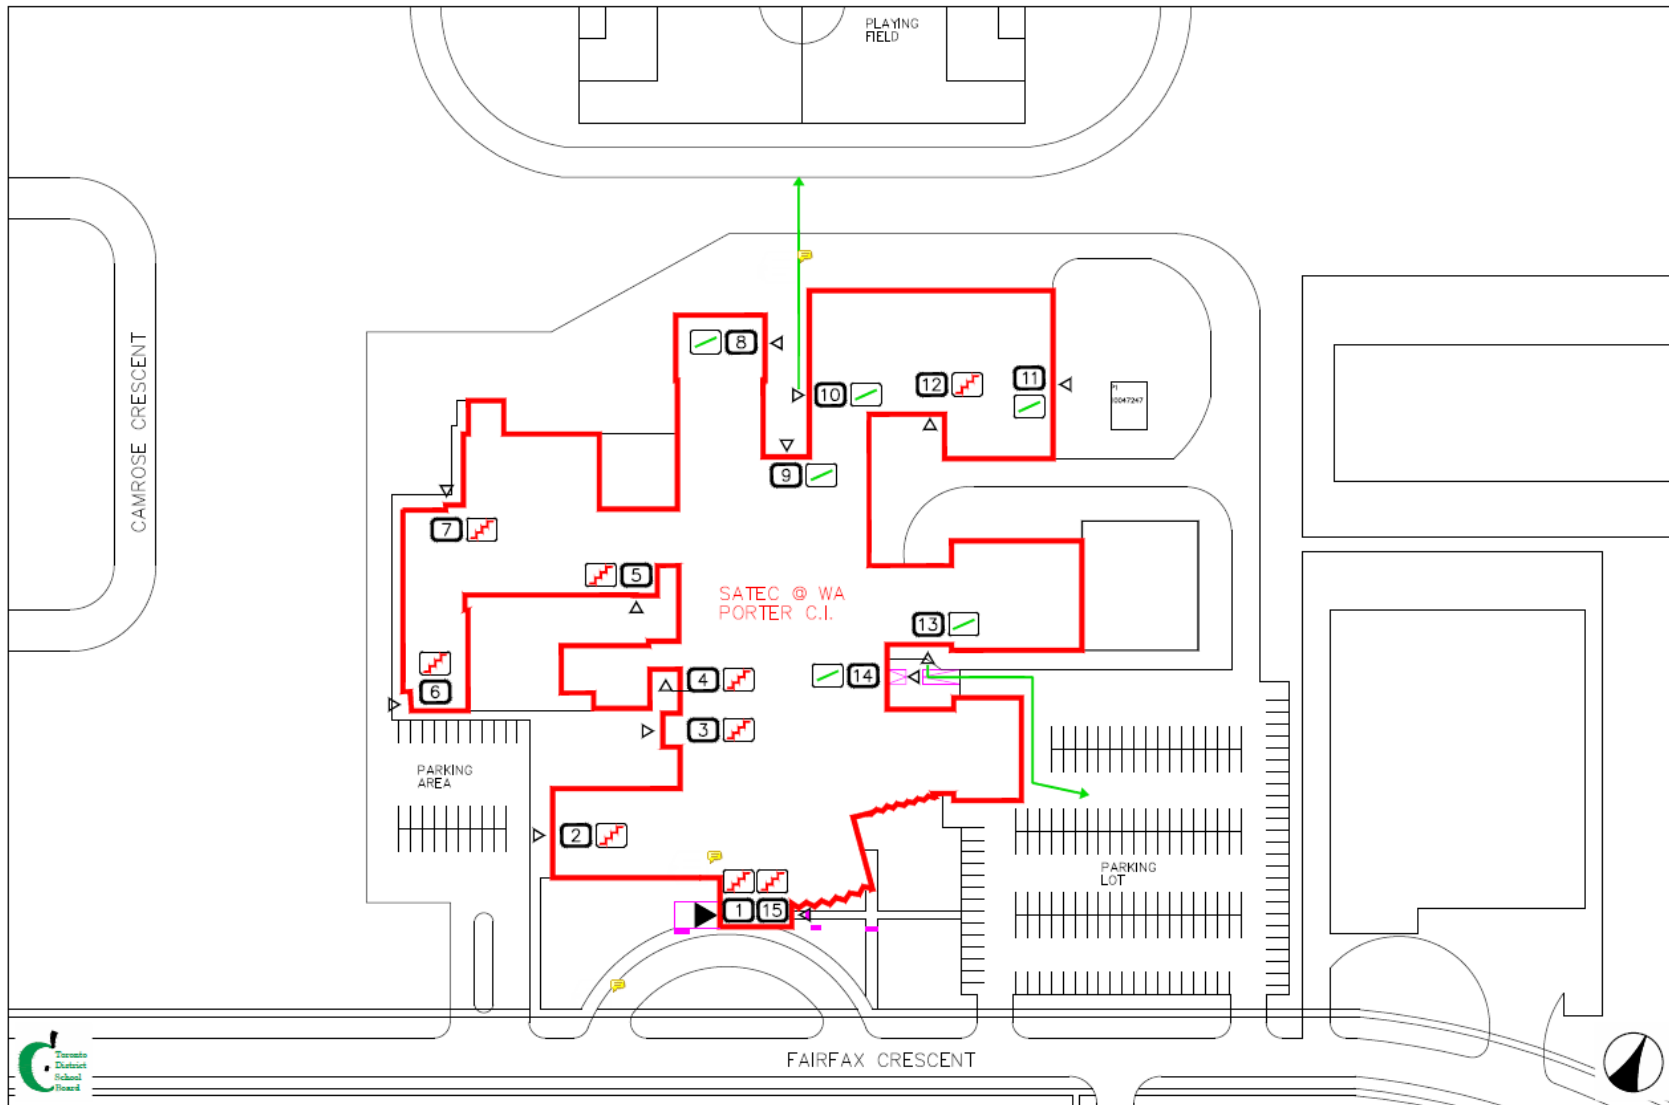
SATEC @ WA Porter Collegiate Institute Site Plan

The school is somewhat accessible. There are no accessible entrances equipped with power-operated doors, and there are no accessible parking spaces. Floor access is also limited to the first floor.

Pathways: Most exterior routes are not accessible. There are steps and stairs around the school forming barriers.

Entrances: None of the entrances are designated accessible or are equipped with a power-operated doors. The main entrance is not accessible because there is a set of stairs leading to it. However, entrances #8, #9, #10, #11, #13, and #14 are either level, sloped, or ramped.
