## **Samuel Hearne Middle School**

21 Newport Ave, Scarborough, ON M1L 4N7

Accessibility survey date: July 2014

For public: summary  
and site plan

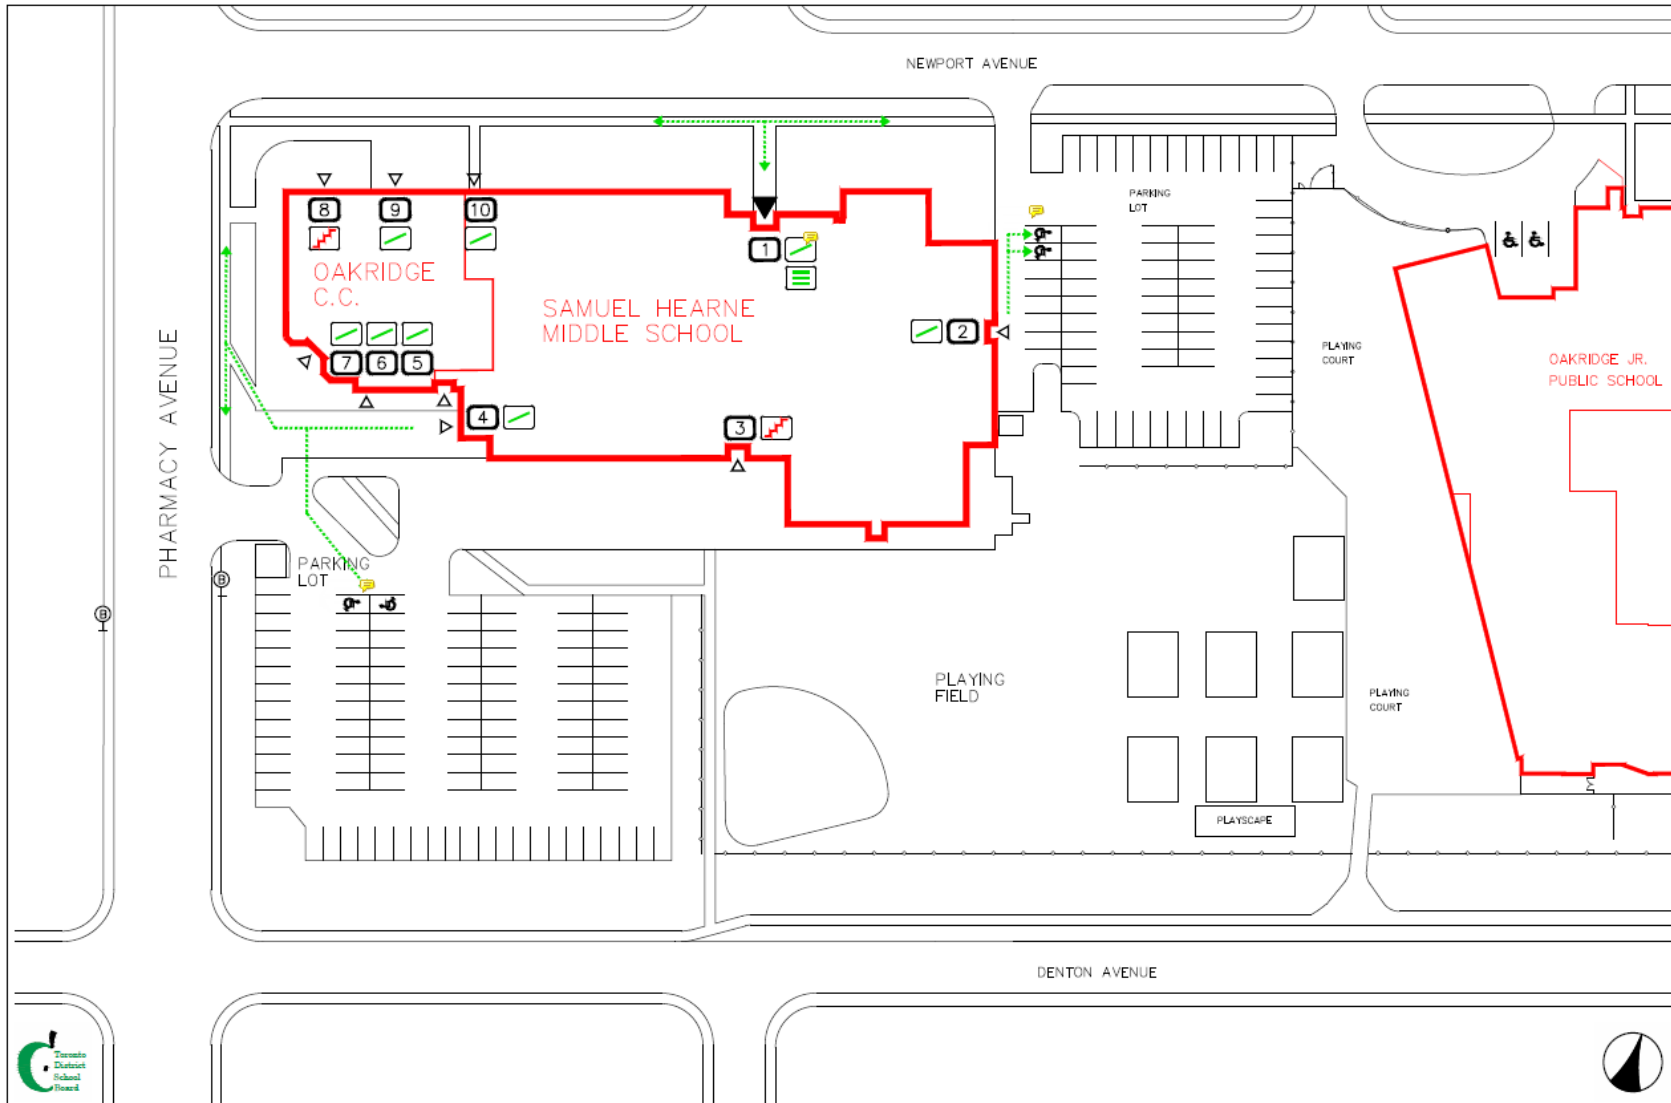
**Samuel Hearne Middle School Site Plan**

The school is not accessible. There are no designated accessible entrances equipped with power-operated doors. Also, floor access is limited to the first floor as there is no elevator in the building. Furthermore, there are no accessible washrooms.

**Parking:** There are two accessible parking spaces near entrance #2, and there are two accessible parking spaces near entrance #4.

**Pathways:** Most exterior routes are accessible. The inaccessible routes have barriers such as potholes, cracking in the pavement, and stairs.

**Entrances:** There are no entrances equipped with power-operated doors, however, all the entrances for the school are level with the ground.

**Floor Access:** There is no lift in the school, so the second floor is inaccessible.
