# Wilkinson Junior Public School

Accessibility survey date: August 2014

For public: summary  
and site plan

### Accessibility: Features and Barriers

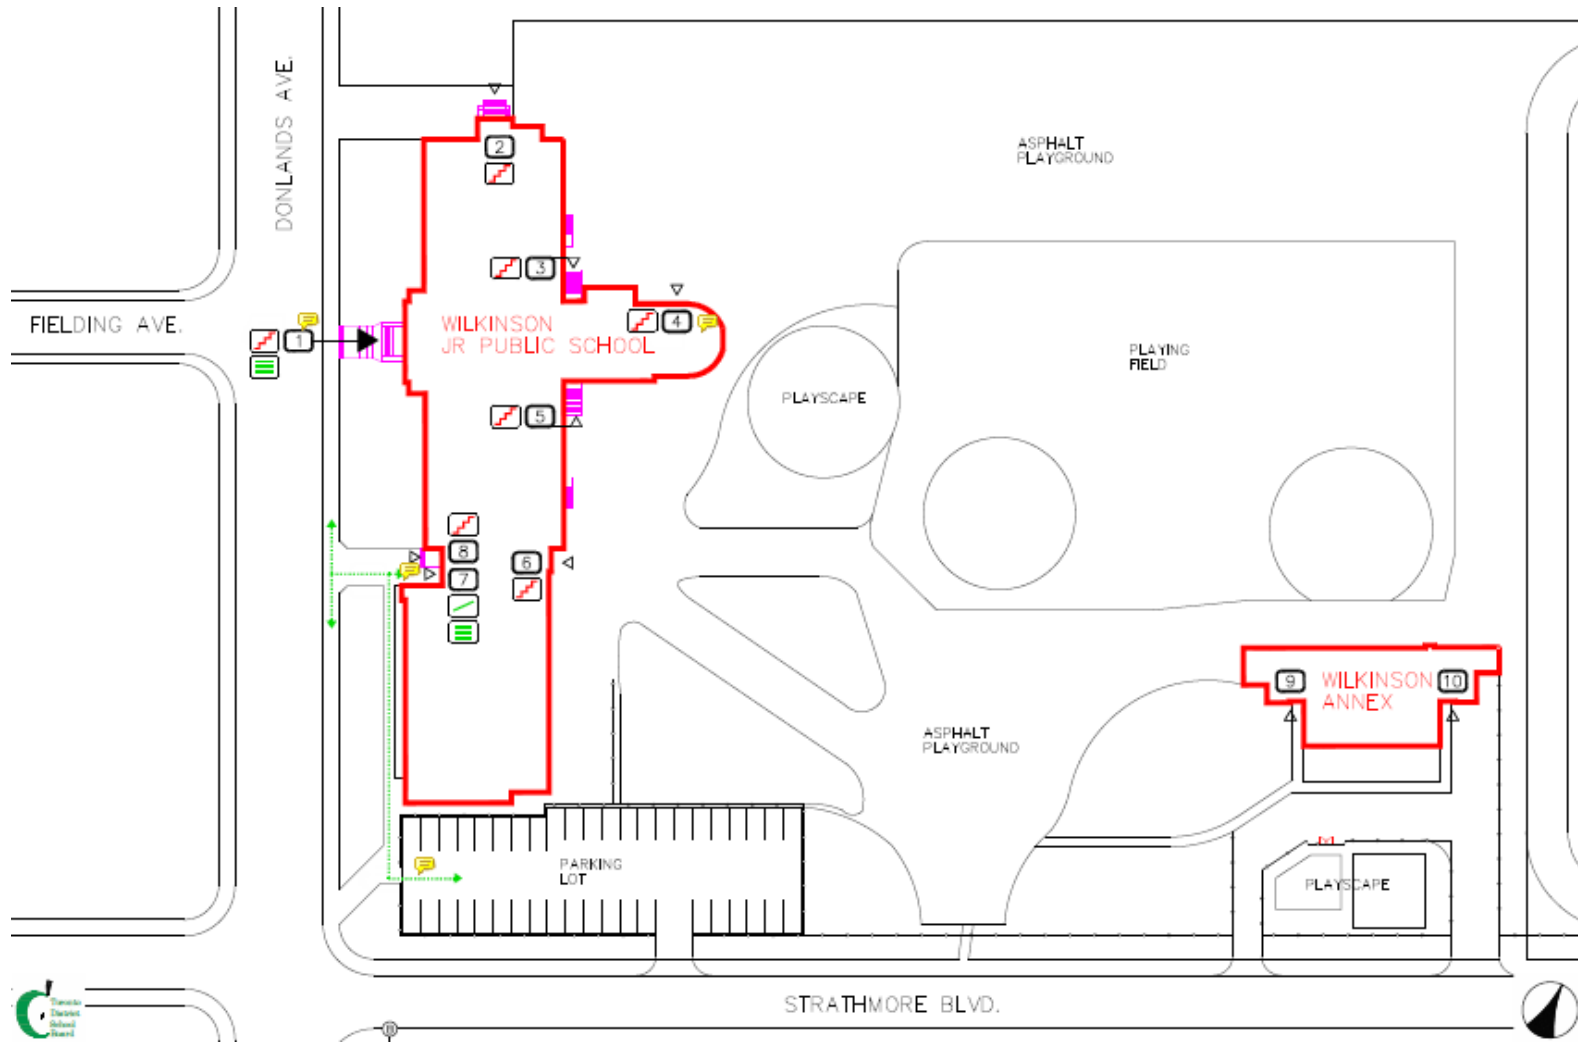
**Wilkinson Junior Public School**

The school is not accessible. All entrances have barriers. There is also no elevator to facilitate access to the upper floors. The basement is the only floor that can be accessed by an entrance.

**Entrances:** None of the entrances is equipped with a power-operated door. Entrance #7 is level, but all the other entrances have barriers such as steps or stairs.

**Floor Access:** There is no elevator in the building, but the basement is accessible through entrance #7.

**Washrooms:** There are two accessible washrooms in the basement level.
