# Weston Collegiate Institute

Accessibility survey date: July 2014

For public: summary  
and site plan

### Weston Collegiate Institute

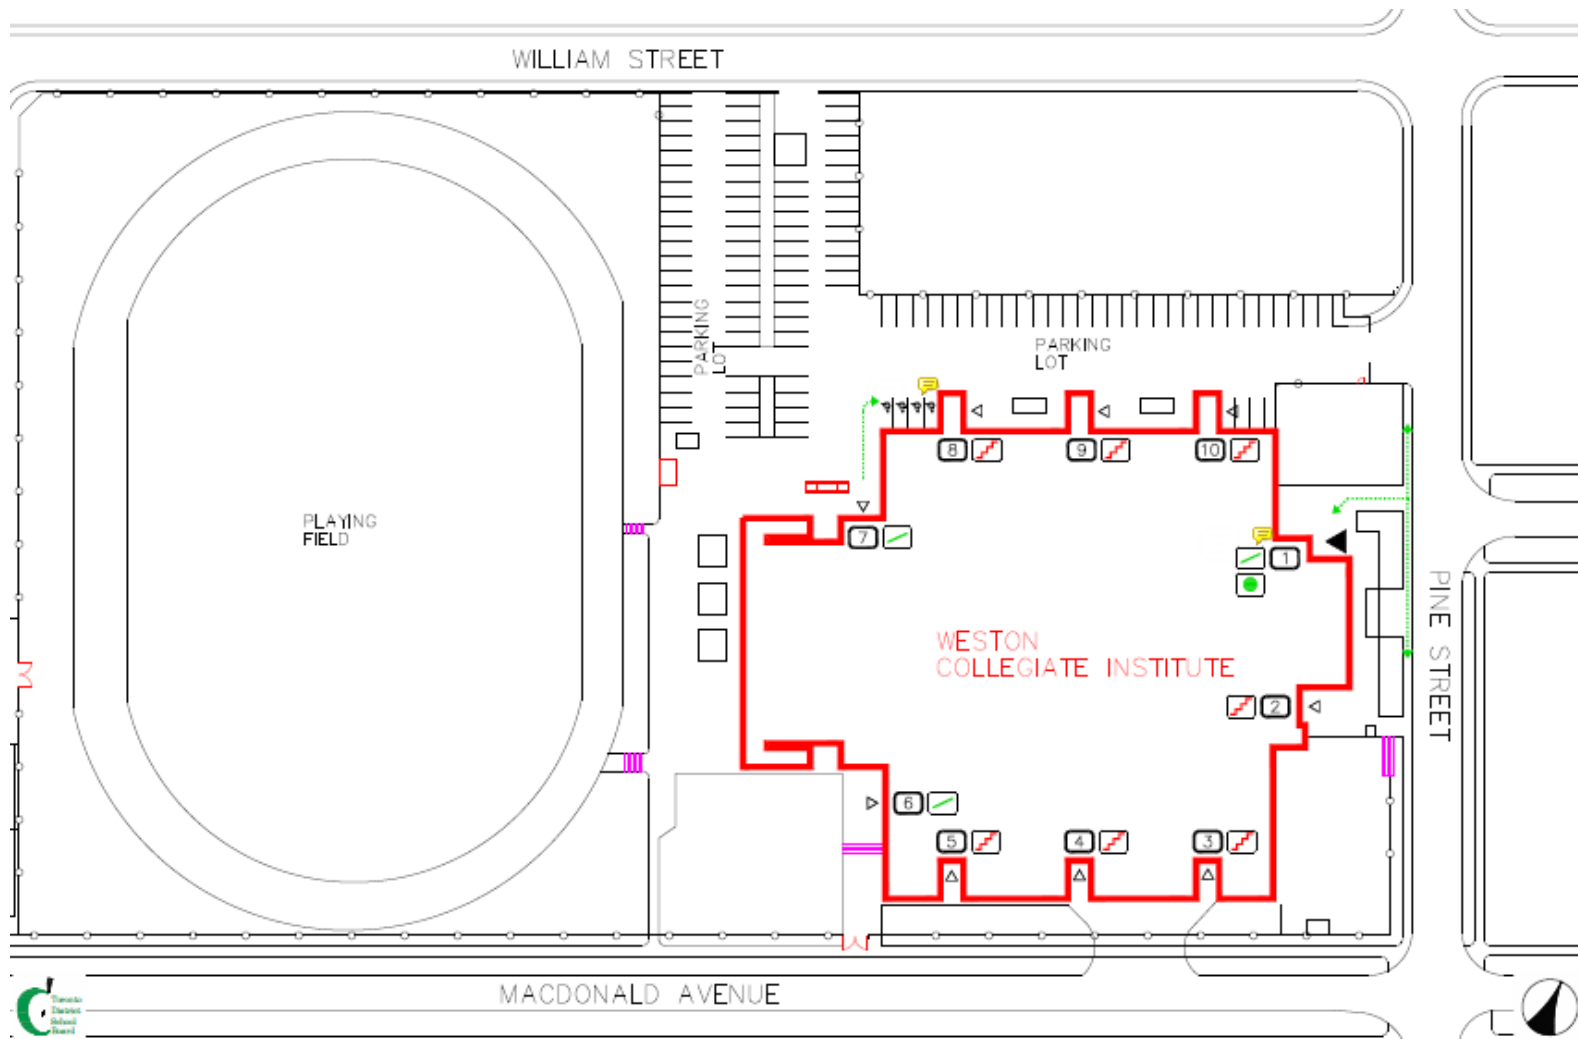
The school is accessible. Visitors can use the elevator to access all the floors. There are also other amenities at the school.

**Parking:** There are two accessible parking spaces.

**Pathways:** The route to the playing field is inaccessible as there are stairs on the pathway. All other routes are level.

**Entrances:** The main entrance is sloped and accessible; doors are power-operated. In addition, entrances #6 and #7 are level.

**Floor Access:** An elevator facilitates access to all floors. However, there are some changes in level that are not addressed by ramps or lifts.

**Washrooms:** There is one accessible washroom located on the second floor.
